FT-817 final amplifier self-oscillation problem

# A simple cure that worked\*

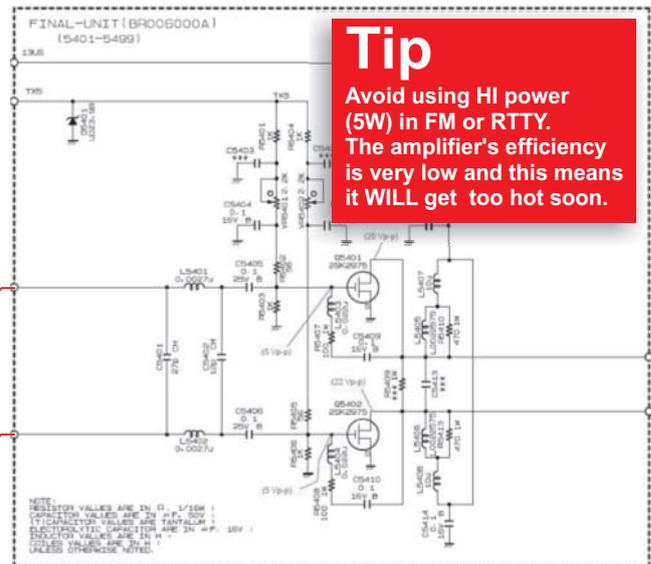
**A**fter replacing my FT-817's finals for the third time, I could take no more! So I set out to find what caused the problem. After several tests (which took two more sets of transistors...) I was convinced that the problem was self-oscillation of the final amplifier during transmission. This phenomenon occurred more when the rig was hot (after a few transmissions) and was very obvious on the screen of my spectrum analyser. Also, the HIGH SWR indicator flashed (the parasitic power appeared as reflected power to the rig) and the power indication showed fluctuation and instability, signs I had noticed on several occasions just before the amplifier blew. If I continued transmitting, after 10 - 15 seconds one of the MOSFETS (I had replaced the original 2SK2975s with RD07MVS1s) would develop a short from gate to source. Amplifier gone!

input coaxial cable

**This is what finally worked well, and is very simple to do:** A series resistance of a few ohms is placed in series with the coaxial cable's leads at the input of the amplifier. The photos and schematics explain the modification, which was performed in December 2007. The rig has performed flawlessly since, and I hope you get the same good results! (After the mod, I have severely "tortured" my 817 to make sure it's really rehabilitated! So far, so good! It seems to take abuse like high SWR or prolonged transmissions like it should.)

I soldered one end of each resistor on the PCB input pads of the amplifier (the resistors are soldered almost perpendicular to the PCB) and then soldered the coaxial cable's ends on the free edges of the resistors. I took care so that the cable wouldn't pull on the resistors, because that could easily break-off the metallisation (solder contact) of the resistors. There was a slight reduction in output power, which is normal (about 300 mW less on all bands at the 5W setting).

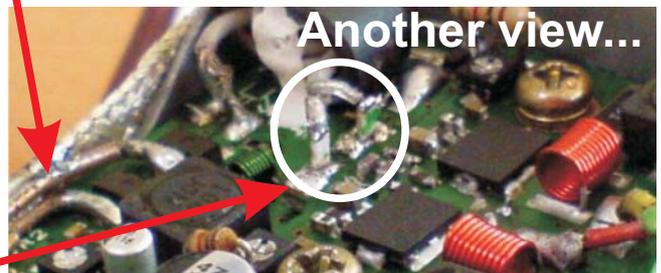
**This is the mod: Just add two chip (SMD) resistors!**

**R1 = R2 =  
 = 6.8 ~ 22 ohm**

In stubborn cases, use higher values of resistance, until the oscillations stop. In my case, 6.8 Ω worked just fine.

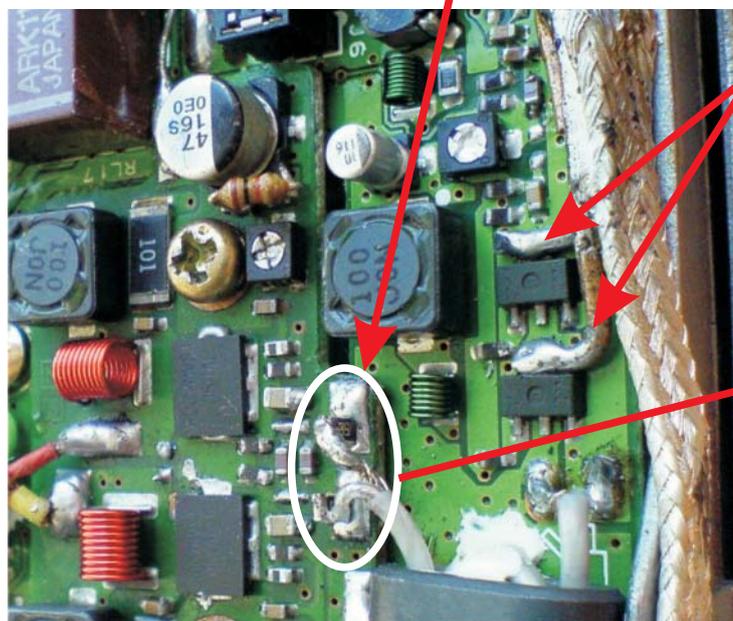
**Another proposed improvement:** Solid copper wire (Ø = 1.5mm) and silver plated braid soldered to the driver transistors' tabs to aid in heat sinking
