IC-7000 driver amplifier self-oscillation problem

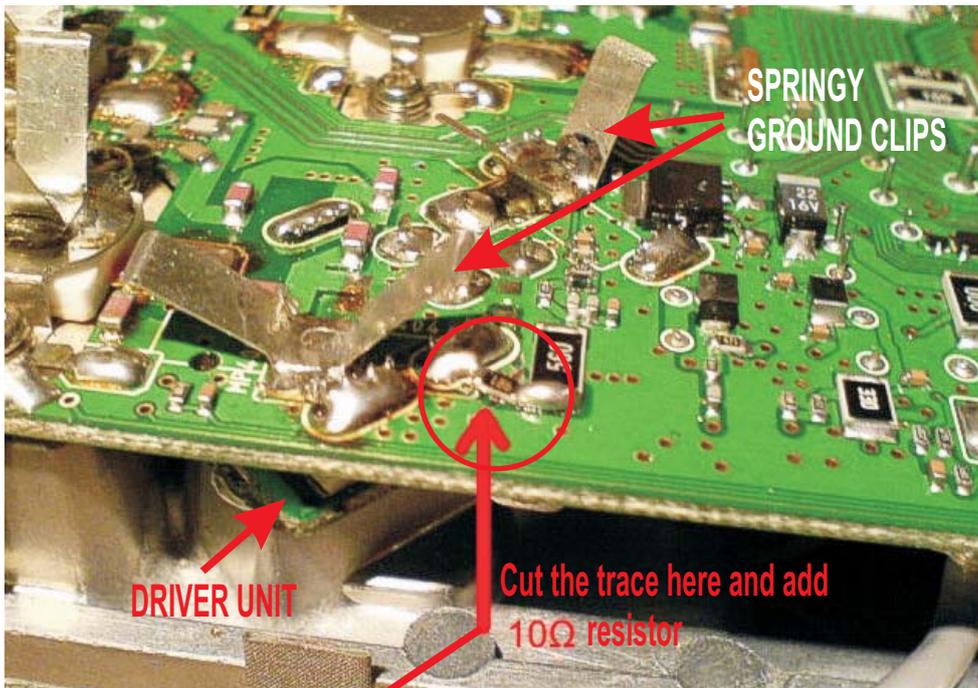
The problem probably lies with self-oscillation of the common driver stage of the TX amplifier chain. A series resistance of a few ohms is placed in series with the input (gate) of the FET amplifier, by cutting the appropriate PCB trace. The photos and schematic explain the modification. It is very simple to do, and can help prevent this "smoking" failure mode, without any side-effects and at negligible cost.

This mod lowers the Q of the copper trace circuits feeding the driver amplifier's input, therefore quenching any tendency of the stage to self-oscillate at some VHF frequency, with destructive results.

IMPLEMENTATION: After removing the covers, locate the driver unit's input trace (see photo), cut it carefully and scrape the solder resistant enamel to expose the copper surface. Then, solder an 10 Ohm (or so...) SMD resistor across the cut of the PCB. That's all!
